STILES & Co

BUILDING SURVEY REPORT

DATE OF INSPECTION: ###

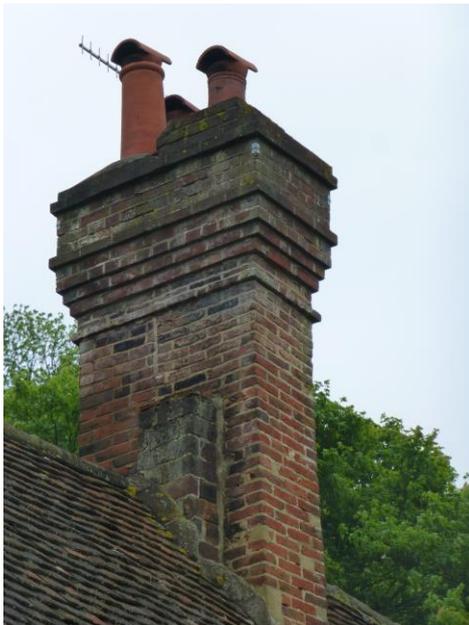
5.1 CHIMNEYSTACK

A triple flue brick chimneystack penetrates the roof at the centre of the house with a mortar fillet/tile listing at its base.

I am pleased to confirm that the chimneystack is satisfactorily plumb and level, with no significant defects apparent. However, there is some erosion of the soft lime mortar pointing and some of the brick faces are delaminating (flaking) as a result of long term weathering.

There are three terracotta pots/cowls, with only one fireplace currently in use. One of the pots is out of plumb and may be loose. I recommend that this is checked and rebedded as necessary, with suitable repairs to flaunchings (mortar bedding) holding pots in place as found to be necessary.

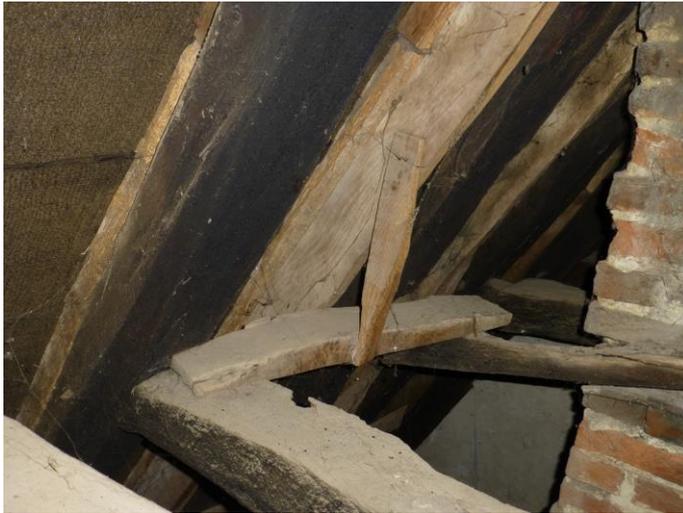
With the exception of a couple of collar ties that have become dislocated at the rear of the chimneystack on the west side and a couple of badly beetle ridden timbers that I recommend are replaced, overall I found the roof framework in satisfactory condition, robust and fit for purpose.

As one would expect there is evidence of widespread historic beetle infestation but nothing to cause concern although there is

some recent activity here and there and some specialsit treatment is recommended to prevent further deterioration.

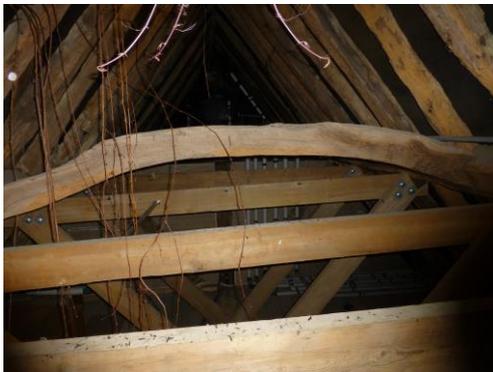
The roof is badly obscured by creepers at the north end and these should be cut away and significantly reduced in size to avoid problems developing. Tendrils have entered the roof space and this is clearly undesirable.

There may be some concealed damaged tiles in these areas and this should be dealt with as part of the overhaul works.

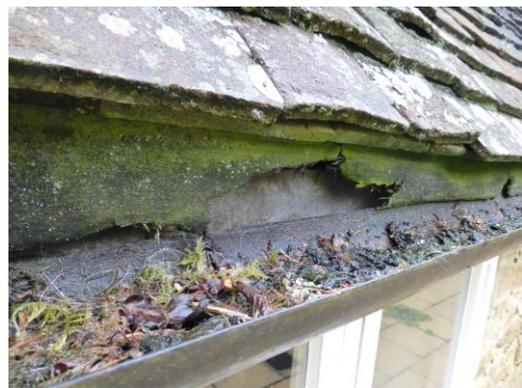
Specifically, there is a dislocated gutter outlet and downpipe at the front left hand corner of the house. Additionally the upper downpipe bracket at the front right hand corner has pulled away from the masonry. Both of these defects require attention.

It is clear that the rainwater gutters have been leaking for some time and this has led to some deterioration of exposed oak rafter feet. In particular rot and beetle infestation at the east side above the ground floor WC. At this point there is a downpipe connecting the upper gutter to a lower section of gutter. Long term overflowing is apparent, with wetting of the low level brickwork, probably contributing to dampness that I identified in the WC.

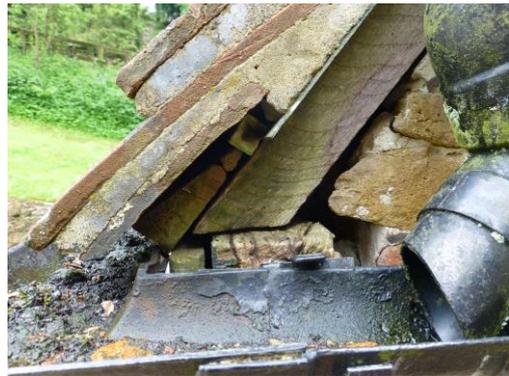
It is clear that this small downpipe cannot cope with the quantity of rainwater from the roof slopes above and will either surcharge (overflow) or cause overflowing of the gutter below.

A single downpipe at the southeast corner of the house is insufficient to deal with the quantity of rainwater runoff and I recommend that the rainwater goods in this area are altered with an additional downpipe introduced, ultimately connected to the underground drainage system.

In view of the above and my earlier observations about some eaves timber remedial work, I suggest that all of the rainwater goods are removed and refurbished to ensure that they are watertight and well painted to prevent premature deterioration.

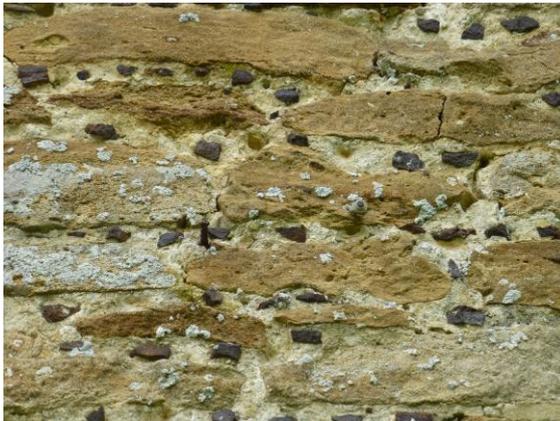
Given the history of the house, it is clear that window and door openings have been infilled and opened up over the years with evidence to confirm that where patched masonry can be seen and the occasional straight joints.

Decorative ironstone galletting has been introduced to the lime mortar joints, which is purely for decorative purposes although with practical origins, where stone masons used hard ironstone spacers to stop heavy blocks of masonry squeezing fresh mortar out of joints.

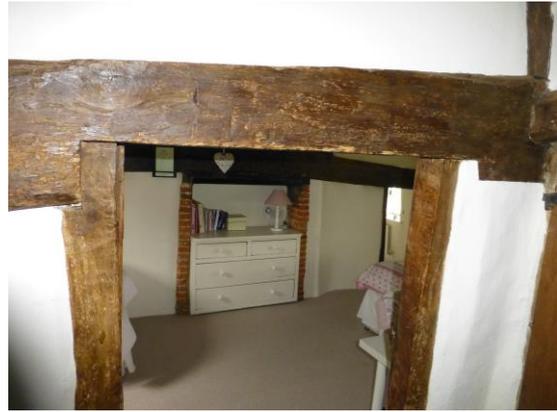
As far as I could determine the original oak box frame remains intact with only minor structural alterations. This includes a slight reduction in the depth of a tie beam where a door has been introduced into the central bedroom. The top of an arch brace has been cut away to allow for the door opening leading to the rear bedroom.

There is no evidence of 'racking' of the oak frame, but this is to be expected given that the frame remains mostly intact and the substantial stone walls around the perimeter will provide a buttressing effect.

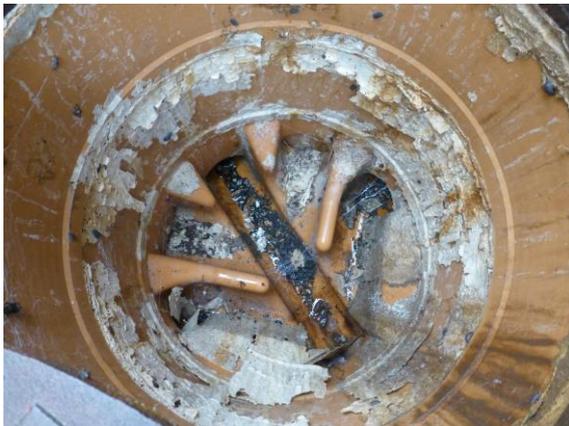
Below the last inspection chamber there appears to be pitch fibre pipework on the outfall, downstream leg. This material was commonly used in the 1960s and 1970s but is well known to have poor durability and can become misshapen with the tendency for the crown of the pipe to flatten and become more oval in cross section. However, in this instance I can confirm that water was running away comfortably with no evidence of any downstream blockages.

I do recommend that as part of any proposed project work a full CCTV survey of the drainage installation is undertaken to determine condition and identify the need for any upgrading. Given the quite shallow invert levels, it is quite possible that much of the drainage installation will need reconstruction, but this will need to be reviewed in due course.

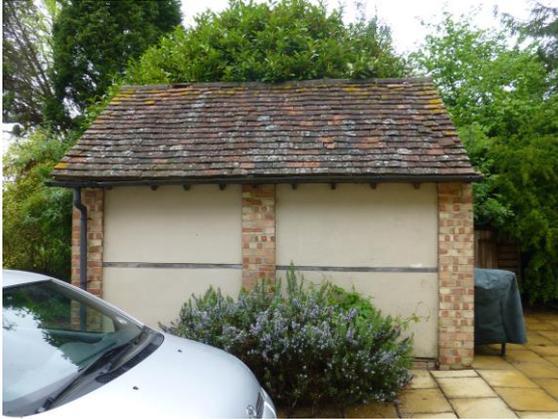
GARAGE

There is a single brick built and rendered garage at the left hand side of the house, standing beneath a simple gable roof. The garage was locked at the time of my survey and no inspection was carried out internally. It is quite likely that there may be rainwater penetration along the left hand side due to the difference in levels but I cannot verify this.

The garage structure, although currently sound, is suffering from long term wear and tear, including deterioration of roof coverings, wet rot to joinery and erosion of brick mortar. If the structure is demolished, these items will of course be of no consequence, but if it is retained, refurbishment of the building is recommended.

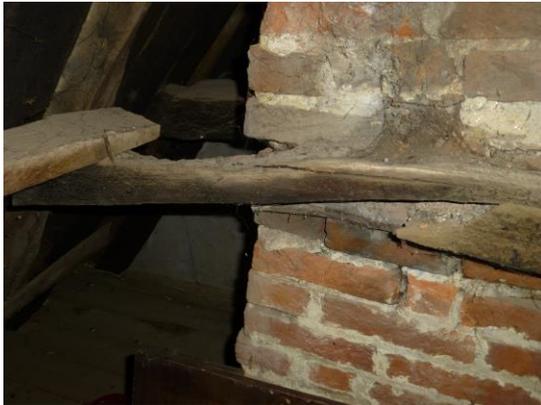
SOUTH

Access into this separate roof space is by means of a hinged bulkhead door at the rear of the inglenook. My findings at this end were similar to the north side, but I did not see any bats here although there is evidence of quite widespread bat activity.

Smoke staining on the roof timbers is quite striking confirming reconfiguration of the roof structure to form a half hipped arrangement.

Crude, but probably effective sealant along the south side has been carried out using expandable polyurethane foam.

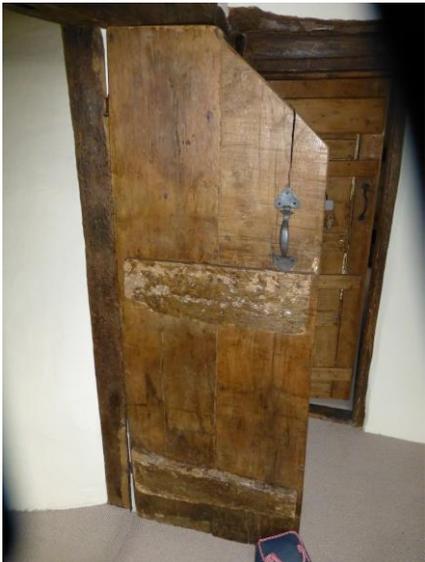
6.5 INTERNAL JOINERY AND STAIRCASES

Oak joinery features throughout, including a number of ancient matchboard/plank doors, with hand forged ironmongery. As with the oak frame there is a combination of historic some more recent and current beetle infestation.

Later in this report I recommend that some specialist inspection and subsequent treatment is carried out to prevent any further deterioration.

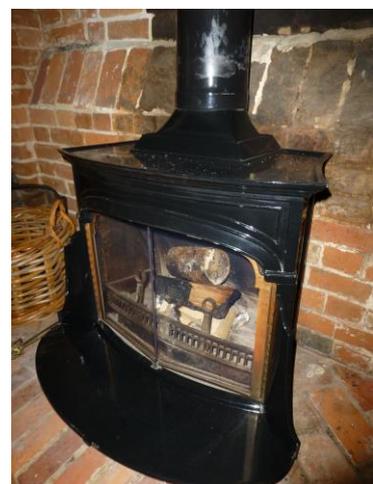
All is as I would expect but I did notice very soft eroded mortar in the brickwork at the left hand side. I recommend that all loose mortar should be carefully raked out and

replaced with lime mortar. At the upper left hand side, currently a plastic bag has been pushed into a rough opening. This should be tidied up.

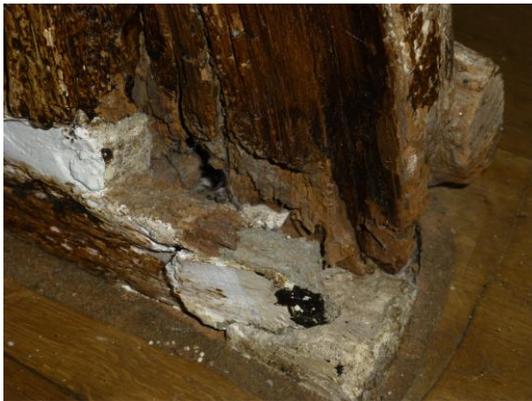
The most significant and most difficult to address, is the rising dampness affecting the living room/kitchen dividing partition, causing softening and proliferation of beetle infestation of the oak sole plate.

This problem is simply to do the lack of any damp proof course with dampness being drawn into the partition base due to long term capillary action.

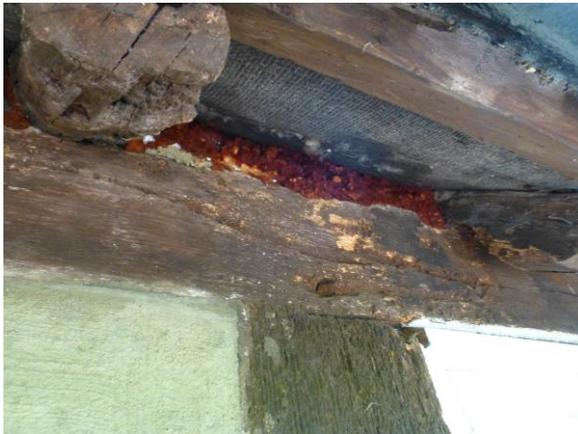
Timbers in the roof space, throughout the accommodation and other joinery show signs of some local beetle infestation, which should be further inspected by a PCA (formerly BWPDA) registered timber treatment company, who should be able to provide an insurance back guarantee for the work.

Below the eaves I found some evidence of long term isolated timber decay. Rafter feet should be prepared or locally replaced as found to be necessary. This problem has been exacerbated by long term leaking rainwater gutters and remedial work should be coordinated with repair or replacement of the gutters.

Please remember that in the roof space, bat friendly chemicals should be used and timing of the works coordinated with their hibernation period.
